**MARYLAND HISTORICAL TRUST  
DETERMINATION OF ELIGIBILITY FORM**

Property Name: Grove Farm Inventory Number: CE-28  
Address: 2125 Grove Neck Road Historic district: ☐ yes ☒ no  
City: Earleville Zip Code: 21919 County: Cecil  
USGS Quadrangle(s): Spesutie  
Property Owner: Maryland Department of Natural Resources Tax Account ID Number: 026828  
Tax Map Parcel Number(s): 9 Tax Map Number: 60  
Project: \_\_\_\_\_ Agency: Maryland Department of Natural Resources  
Agency Prepared By: Paula S. Reed & Associates  
Preparer's Name: Edie Wallace Date Prepared: 11/1/2010

CE-28, Grove Farm  
2125 Grove Neck Road  
Cecil Co., Maryland  
USGS Spesutie Quadrangle

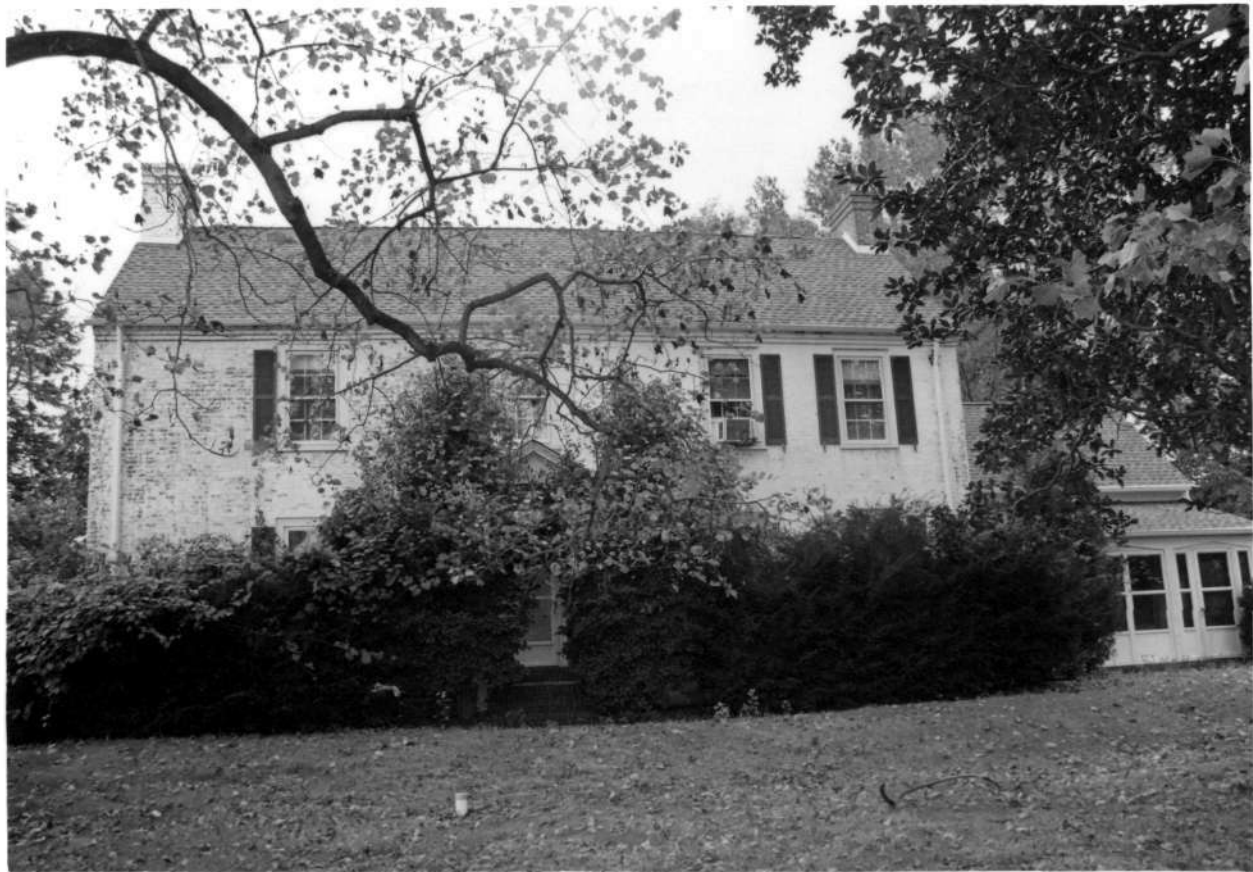
3/38

**Main House:** The main house is a two-story, four bay brick gable-end dwelling built in three sections, on a brick foundation. The house faces south toward the road and the Sassafra River (not currently within view). The western two bays of the main house, including the front entrance and a window, are the original all-brick construction, built ca. 1810, in Flemish bond on the front (south) elevation and in a 5 to 1 ratio common bond on the west gable end. The mortar between the bricks is struck with an incised trowel line. The cornice treatment on both the front (south) and rear (north) elevations is a stepped brick corbel. The eastern two bays of the house, both window bays, appear to be an early 20th century frame addition with brick veneer laid in Flemish bond on the front to match the original and an all-stretcher bond on the east gable end. The cornice treatment is also matched to the original. The brick veneer of the east extension was so skillfully pieced into the original brick construction that only the difference in the adherence of the white paint to the newer, harder bricks identifies the later addition on both the front and rear elevations. Other evidence of the house enlargement includes the original east gable wall with windows in the attic and original brick foundation in the basement.

Main house, S elevation, view N

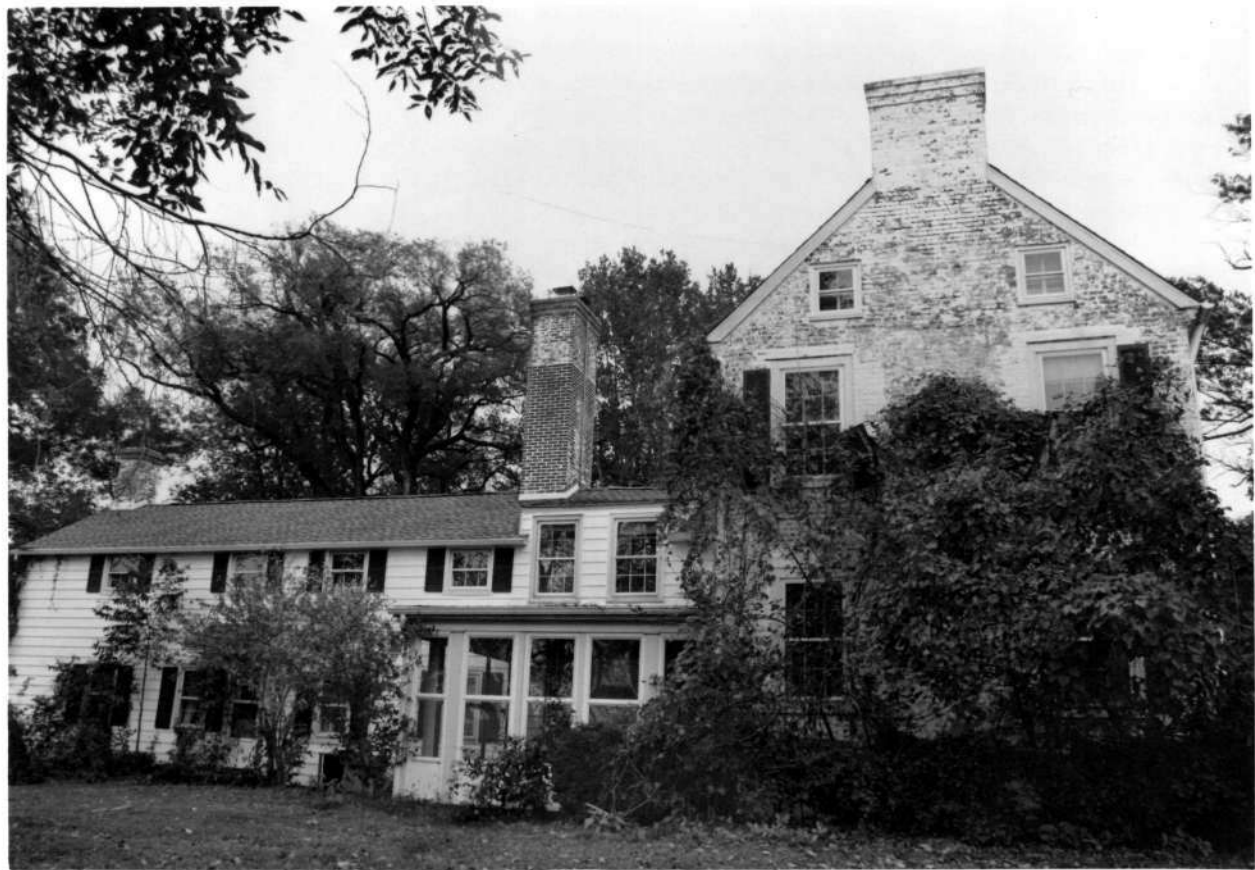
4/38

There is a corbelled brick interior chimney on each gable end of the house. Windows overall are 6 over 6 sash with all frames covered by aluminum sheathing. It appears that original decorative brick treatments above the original windows and door may have been replaced with plain coursed bricks. Windows in the east extension are all topped with metal (iron or steel) lintels (note: this may indicate a ca. 1875 construction date for the east extension when the property was owned by the Harlan and Hollingsworth families with ties to the Harlan & Hollingsworth shipbuilding company, who would have had ready access to such metal accessories), and these window frames are all more deeply recessed from the brick façade than the windows on the original west end. The front entrance is covered with a pedimented portico. The portico has an arched ceiling with a heavy frieze base and is supported with paired, fluted Doric columns and single squared pilasters. The portico floor and steps are brick. There is a small 1 1/2 story frame addition on the east gable end of the house and a long, frame, 1 1/2 story ell addition on the rear. The small 1 1/2 story frame addition on the east gable end sits on a concrete foundation and is covered with vinyl siding.

Main house, W elevation, view East

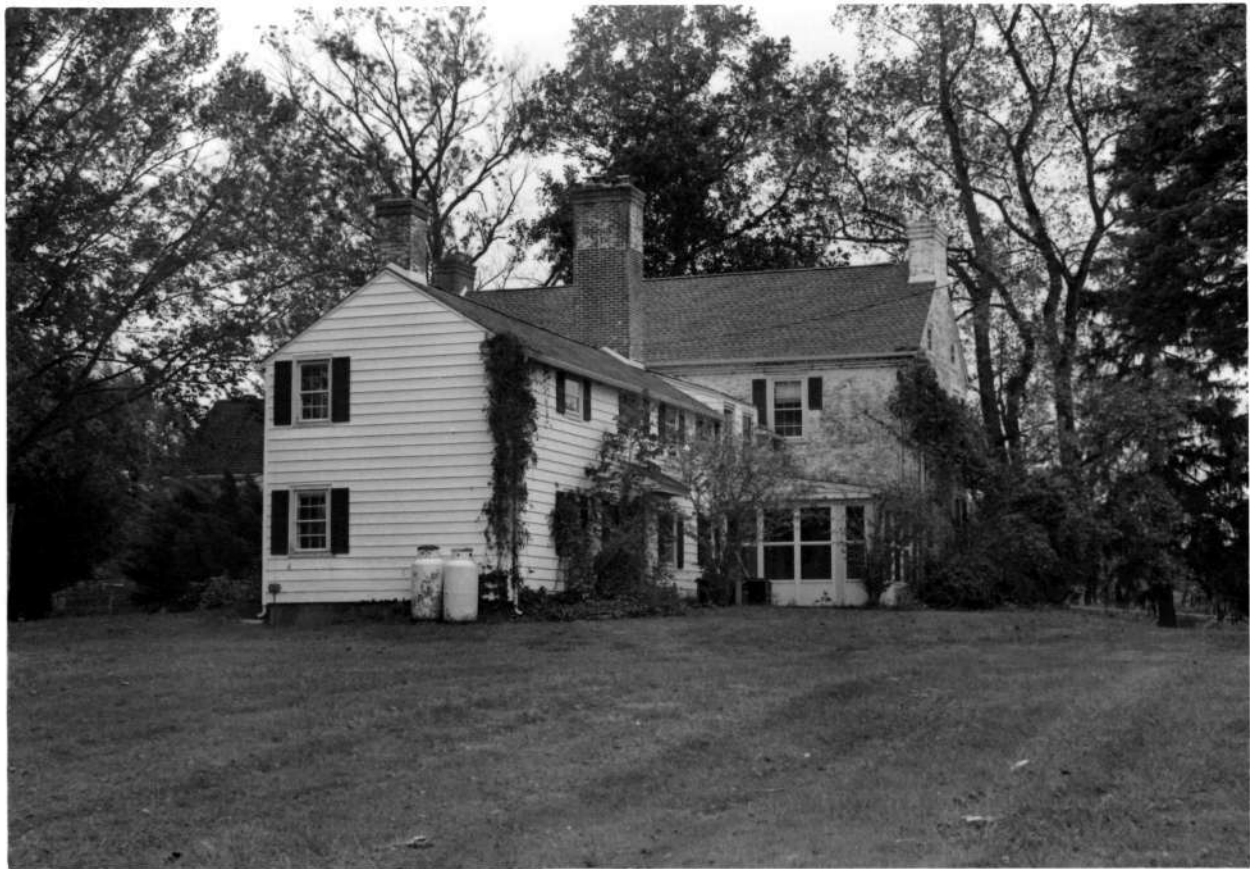
5/38

The rear addition to the main house appears to be timber frame, built ca. 1855, possibly prior to the expansion of the main (front) block of the house. This rear service wing is 1 1/2 stories high and extends north approximately 40 feet. It is covered with vinyl siding. There is an interior brick chimney on the north gable end and a massive, tall brick chimney extending from the middle of the addition. An added atrium extends from the west elevation and an enclosed shed-roofed porch runs nearly the whole length of the east elevation.

Main house, N elevation, view SE

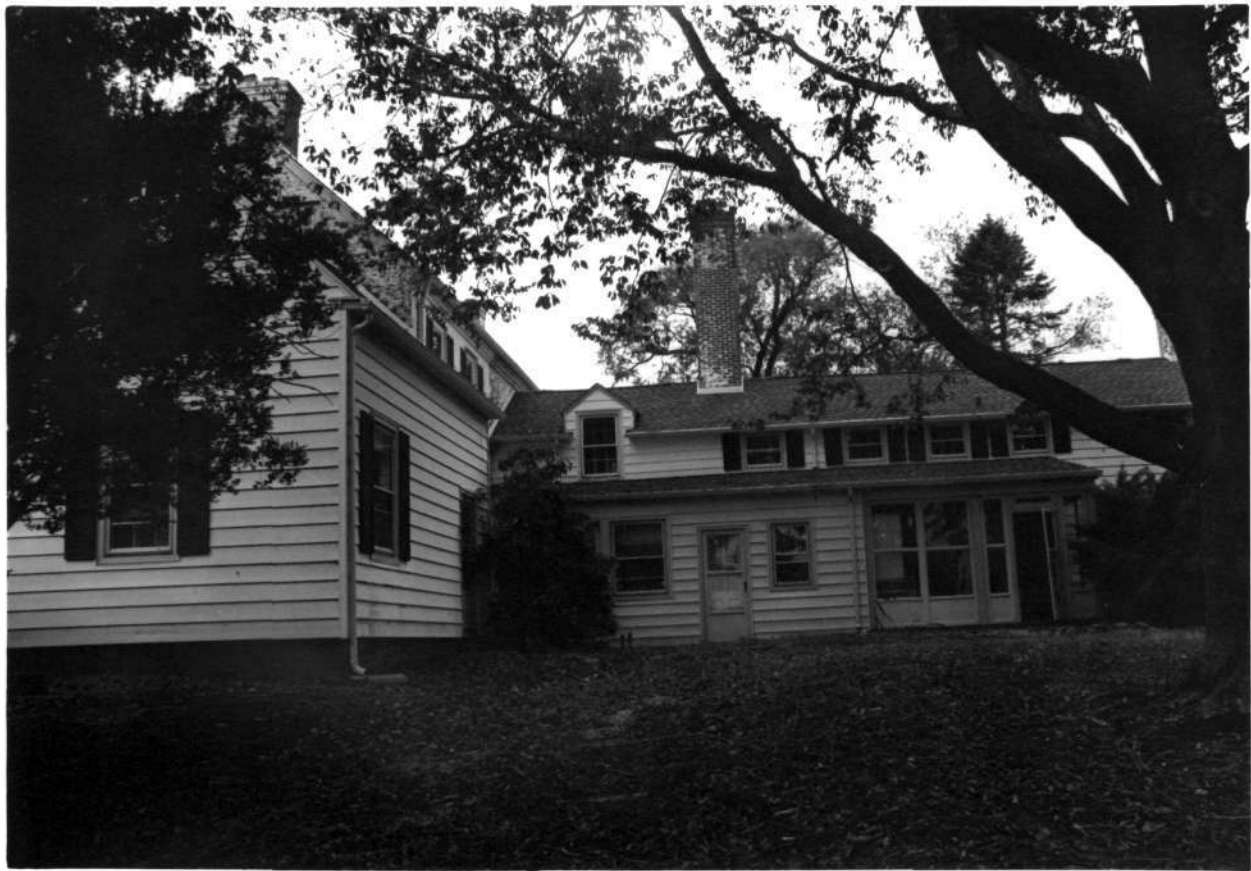
6/38

Main House, E elevation, view West

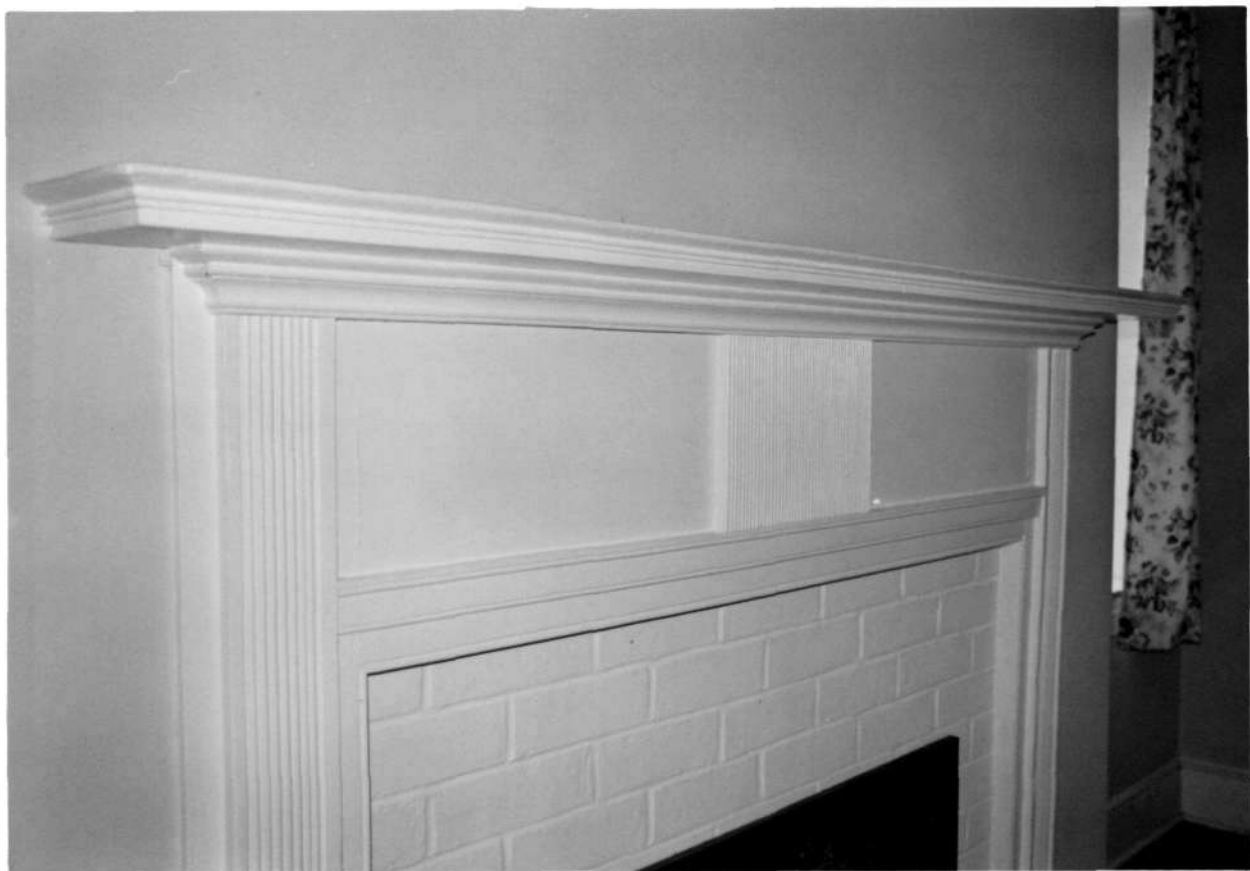
9/38

West wall retains an original mantelpiece with reeded pilasters, a broad frieze and central reeded tablet. Courses of cavetto and bolection moldings support a narrow mantel shelf. A door through the original brick east wall of the stair hall opens into the east room at the base of the stairs. This room was converted to a library ca. 1940 with heavy Colonial Revival knotty pine paneling and shelving. There are two windows in the south wall and a fireplace in the east wall. A door in the east wall leads into the ca. 1940 1 ½ story east addition. A door in the north wall opens into the rear (north) addition with three steps down.

Main house interior, west parlor, west wall mantle detail  
view NW

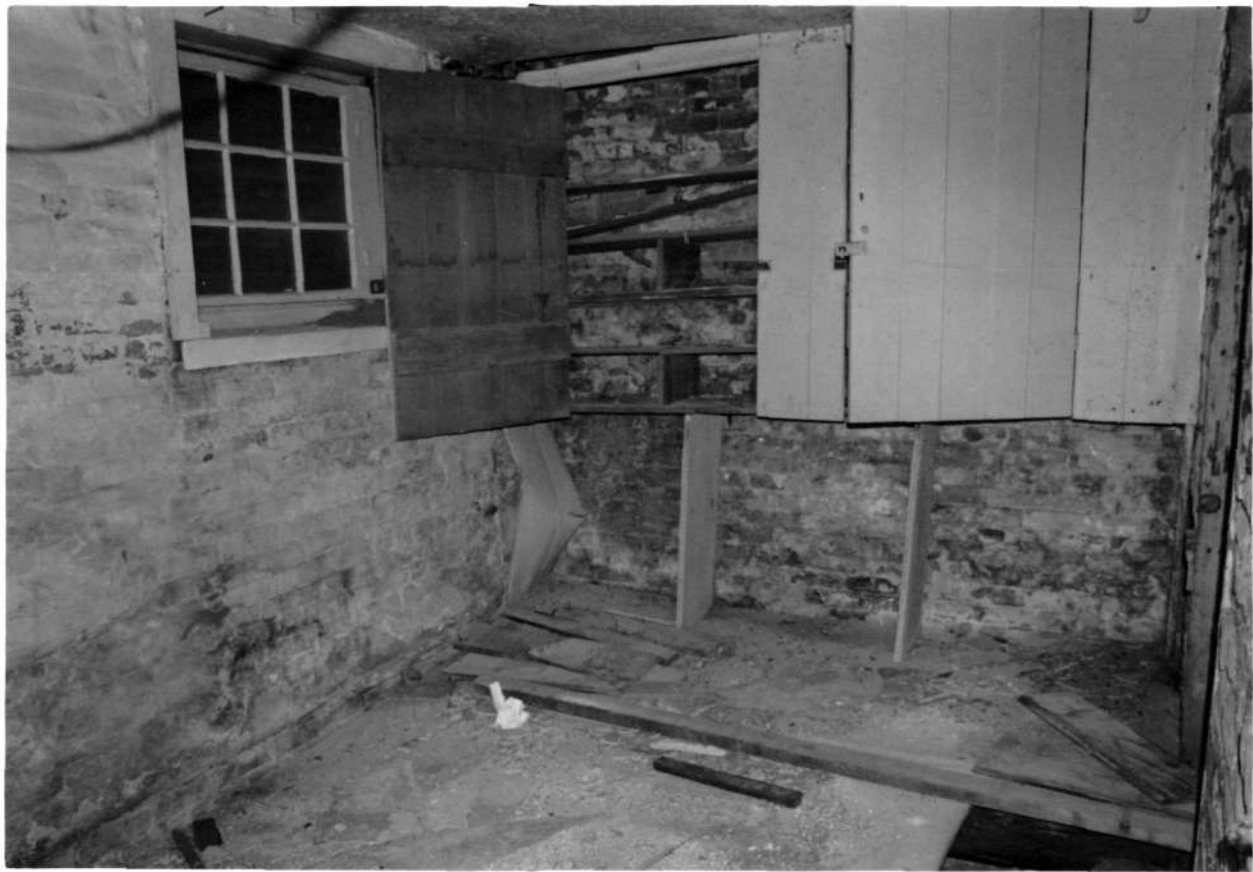
12/38

Main house interior, cellar, view SE showing original  
brick east foundation wall

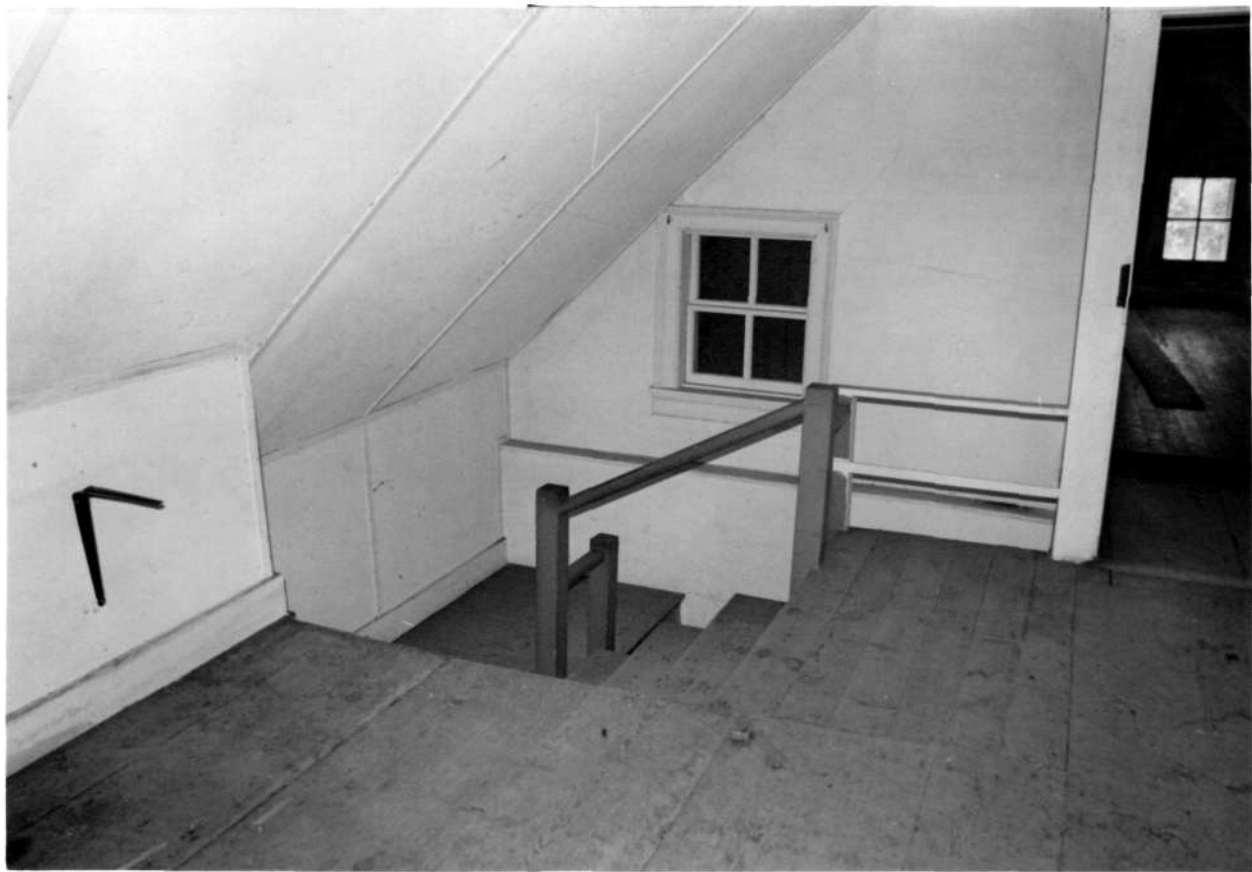
13/  
38

Main house interior, attic, view NE showing original  
east gable

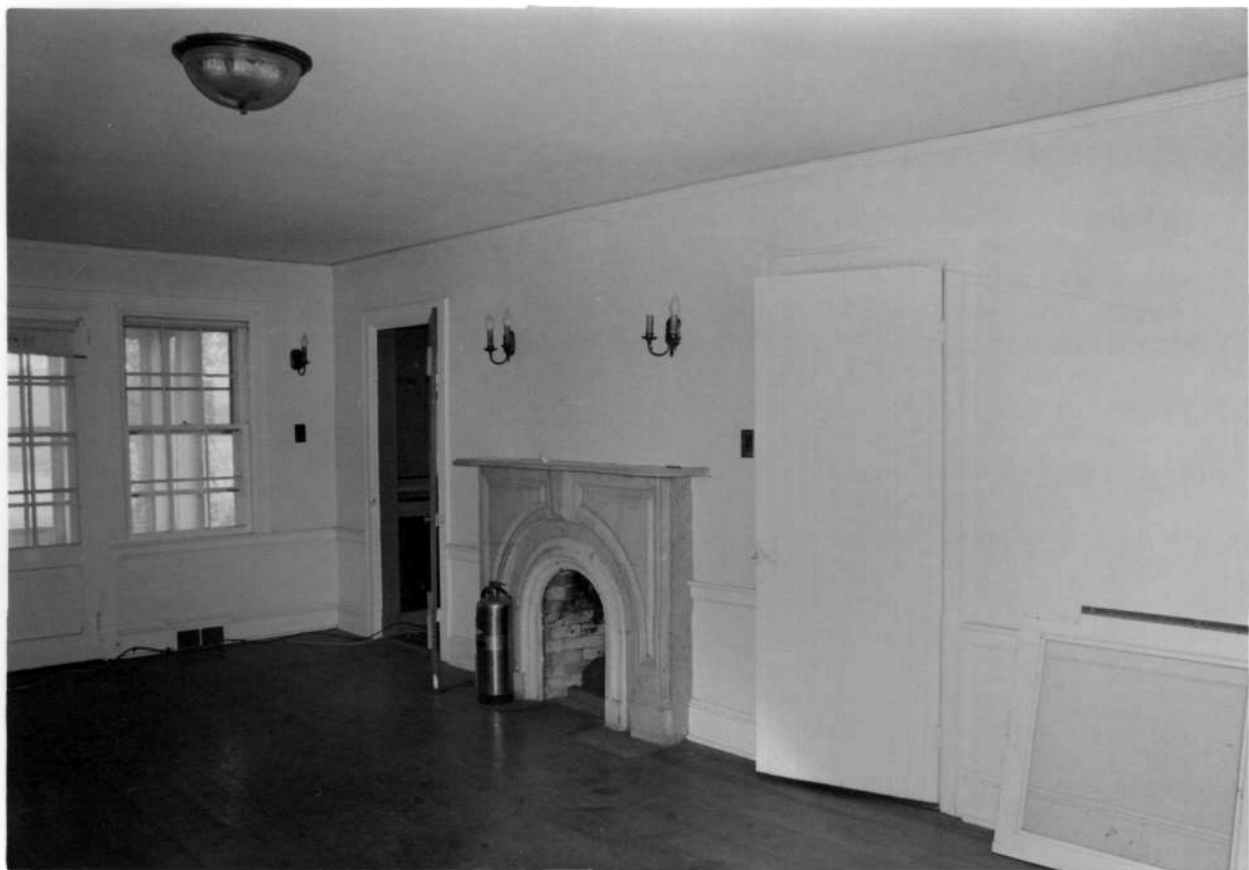
14/  
38

The ca. 1855 rear (north) addition appears to have been constructed prior to the east extension of the brick house. The large room accessed through the stair hall's north (rear) door was enlarged eastward expanding into and enclosing a portion of the porch along the east elevation of the rear addition. A fireplace with an elaborate Italianate marble mantelpiece is located off-center toward the west in the current north wall, with a door leading into the kitchen area on the left (west) side and a door leading into the laundry room (enclosed porch) on the right (east) side. The room has chair rail and architrave trim with a back band. The west wall of the dining room has two 6 over 6 sash windows and an exterior door leading into the atrium. The east wall has two 8 over 8 sash windows and an exterior door. A door through the north wall, west of the fireplace, leads to the kitchen, passing through a "wet bar" area, a small passage created primarily by the depth of the massive chimney located between the dining room and kitchen. The kitchen appliances and cabinetry date from ca. 1970. There is an old wood or coal cook stove on the south wall connected to the massive chimney. A door in the southeast corner leads into the enclosed porch laundry room. There are two 6 over 6 sash windows and an exterior door in the west wall. There is one window and an exterior door in the east wall leading into the enclosed porch. A door in the north wall opens into the northern-most room of the rear addition which appears to have been a summer kitchen/wash room. A large projecting fireplace with an attached base for the large iron kettle or boiling pot is located on the north wall, along with a window. There is an exterior door and window in the east wall and a window in the west wall. In the northwest corner is an enclosed winder stair with closet beneath, which ascends to the upper story service quarters. Doors for the stair and closet are board and batten and the stair enclosure tongue and groove vertical paneling. Trim is plain and without a molded back band. The upper level consists of three rooms accessed along a narrow hall lit by knee windows. Floor boards are wide, tongue and groove and applied with cut nails.

Main house interior, rear (north) addition, S room,  
view NW

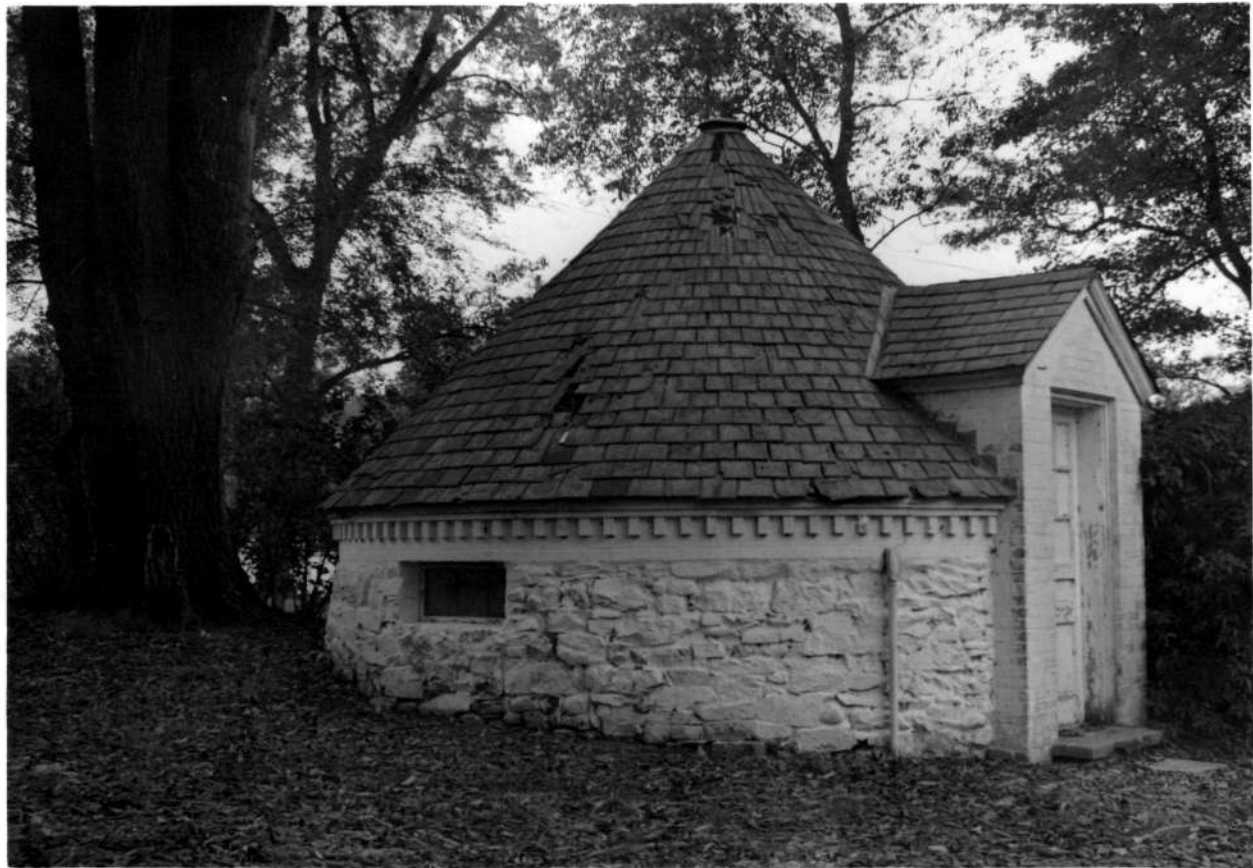
17/  
38

**Ice House:** This is a round building constructed of stone with brick at the upper courses, about 4 feet above ground level with a conical roof. It extends in stone approximately 15 feet into the ground. The courses of brick sit on top of the stone base structure and include a decorative dentiled cornice. The wood framed conical roof is covered with gray slate shingles. A projecting gabled doorway built of brick with a slate shingle roof opens to the interior. Inside is a wood floor with a large opening through which the ice could be raised or lowered into the underground storage area. A ladder provides access to the underground space.

Ice House, view NW

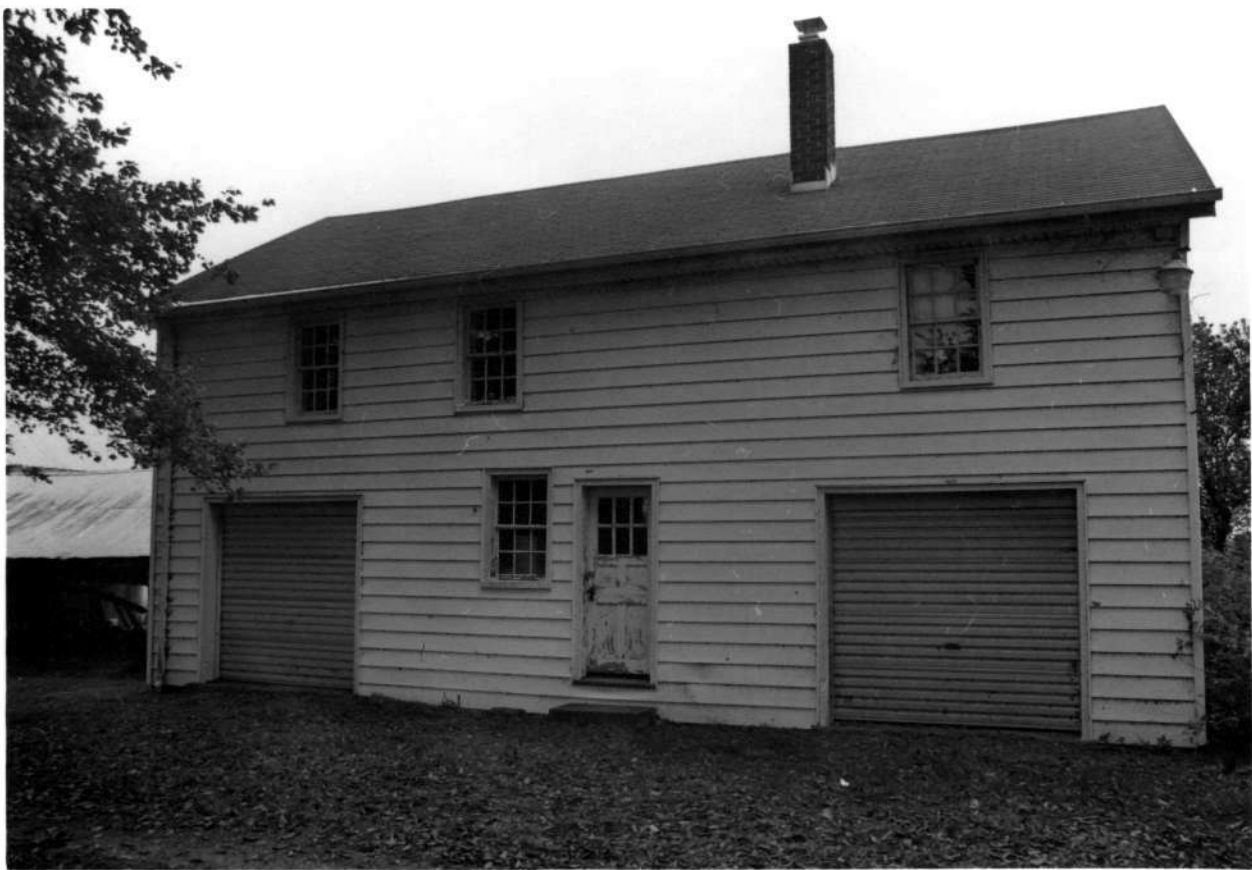
18/  
38

**Quarter/garage:** This two-story, four bay building has a hewn timber frame first story with a lighter frame second story addition. The foundation is stone. The first floor appears to have originally had three apartments, the two end rooms have since been converted to garage bays with the floor boards removed. The center room is still intact with the whitewashed framing exposed on the interior. This room also includes the enclosed stair (outside access) to the second story. The second story is divided into two apartments that appear to date to the first half of the 20th century (possibly ca. 1940). Windows are all 6 over 6 sash. The whole is covered with vinyl siding and an asphalt shingle roof. There is one interior brick chimney.

Quarters/garage, west elevation, view NE

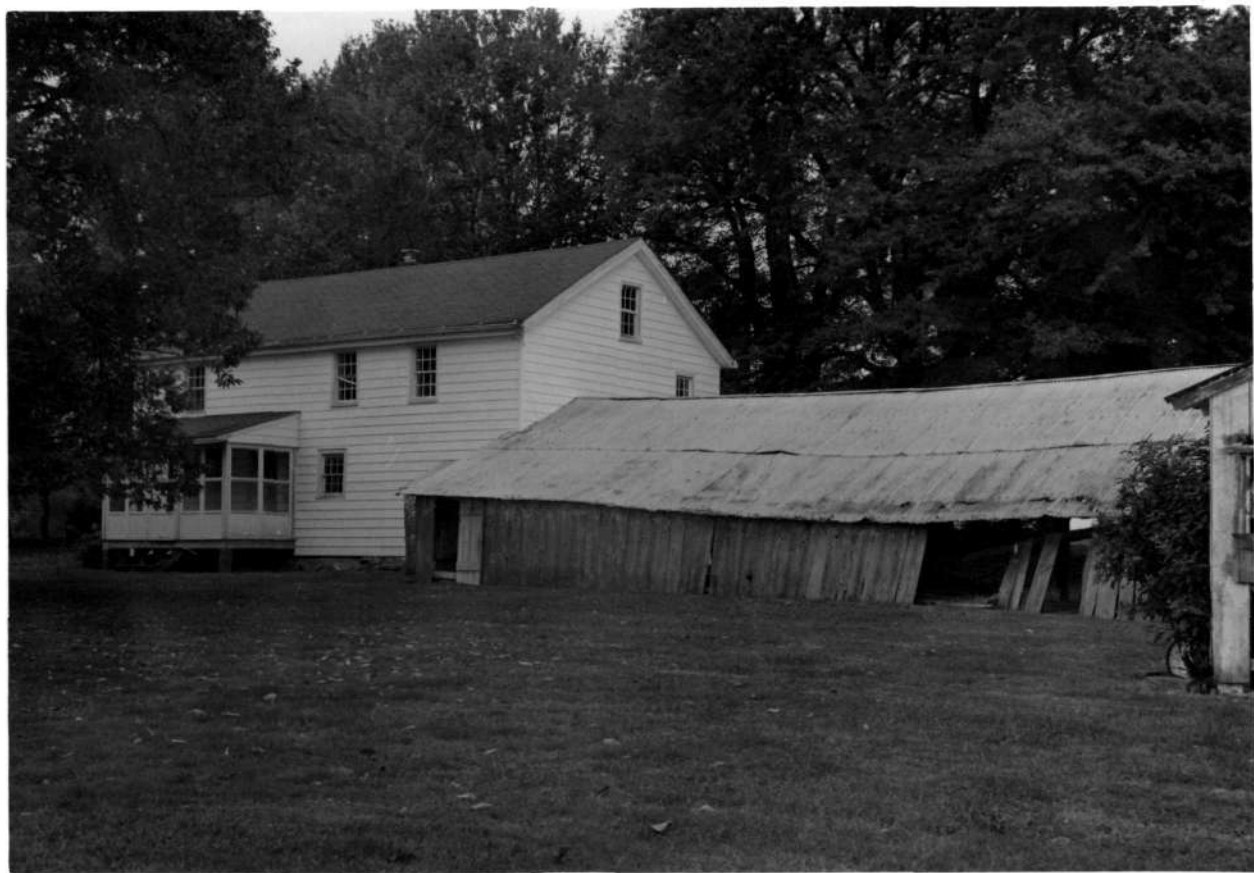
21/  
38

**Attached equipment shed:** A hewn timber frame pole shed, approximately 50 feet long, is attached to the north end of the Quarter/garage. The shed is open along the entire west side. The gabled roof is supported on primarily round log rafters with hewn beams and posts. The back (east) wall is vertical boards. The roof is corrugated metal sheets. The shed is attached on the north end to the Wagon Shed/Corn Crib.

Quarters/garage, north and east elevations, view  
SW showing attached equipment shed

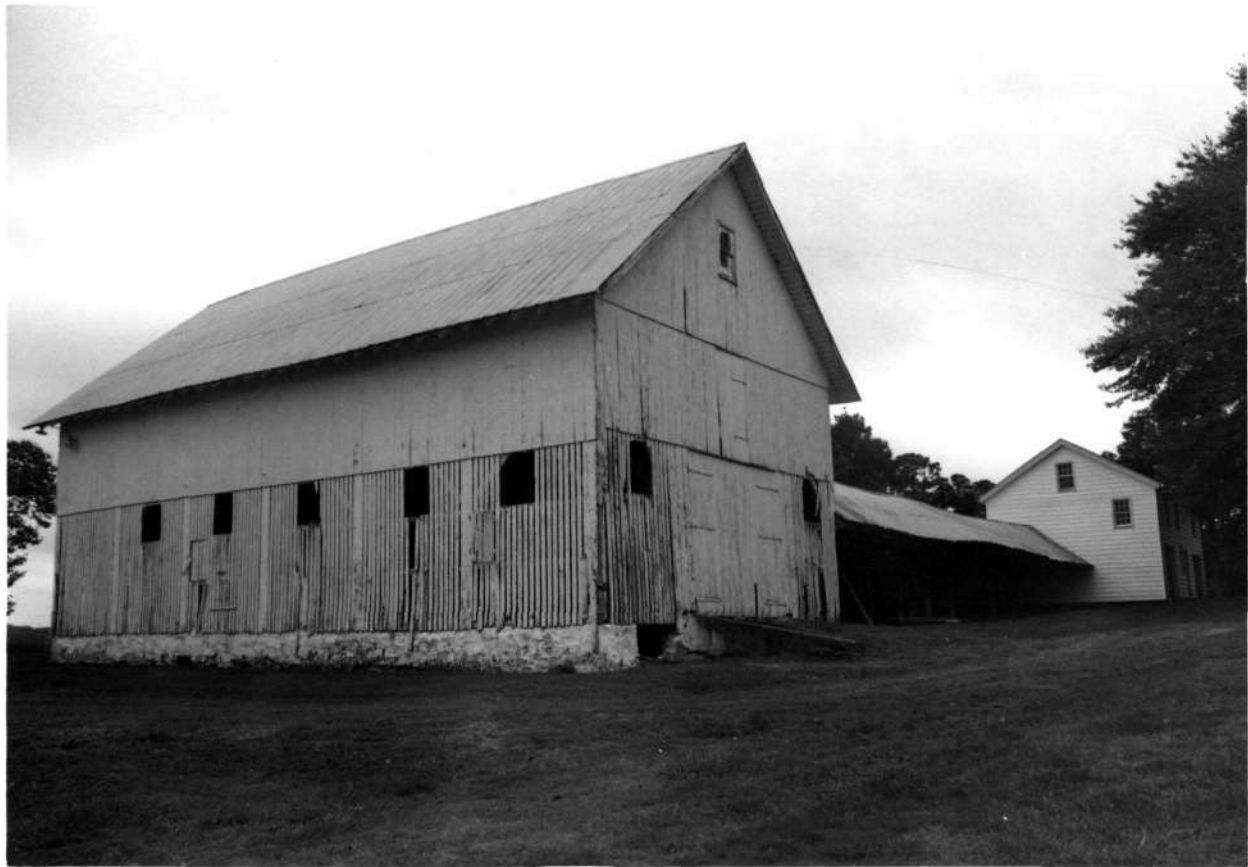
22/  
38

**Wagon Shed/Corn Crib:** This two story building is hewn timber framed with a center wagon bay accessed by large paired board and batten doors. Open slatted corn crib enclosures extend along the south and north sides of the building, with built-in wooden

Wagonshed / Corncrib, north and west elevations,  
view SE showing attached equipment shed and  
Quarters / garage

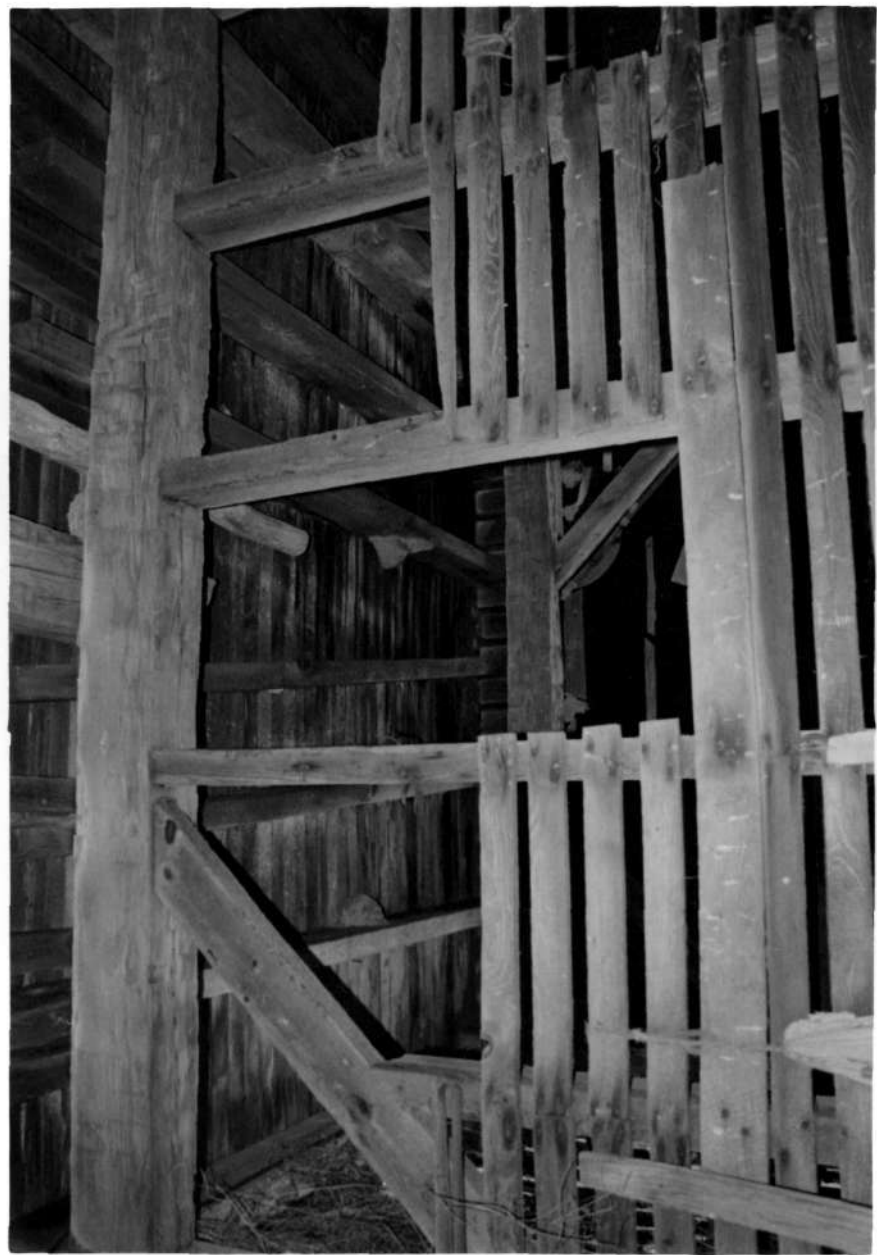
23/  
38

Wagonshed/ Corncrib interior, detail showing hewn framing

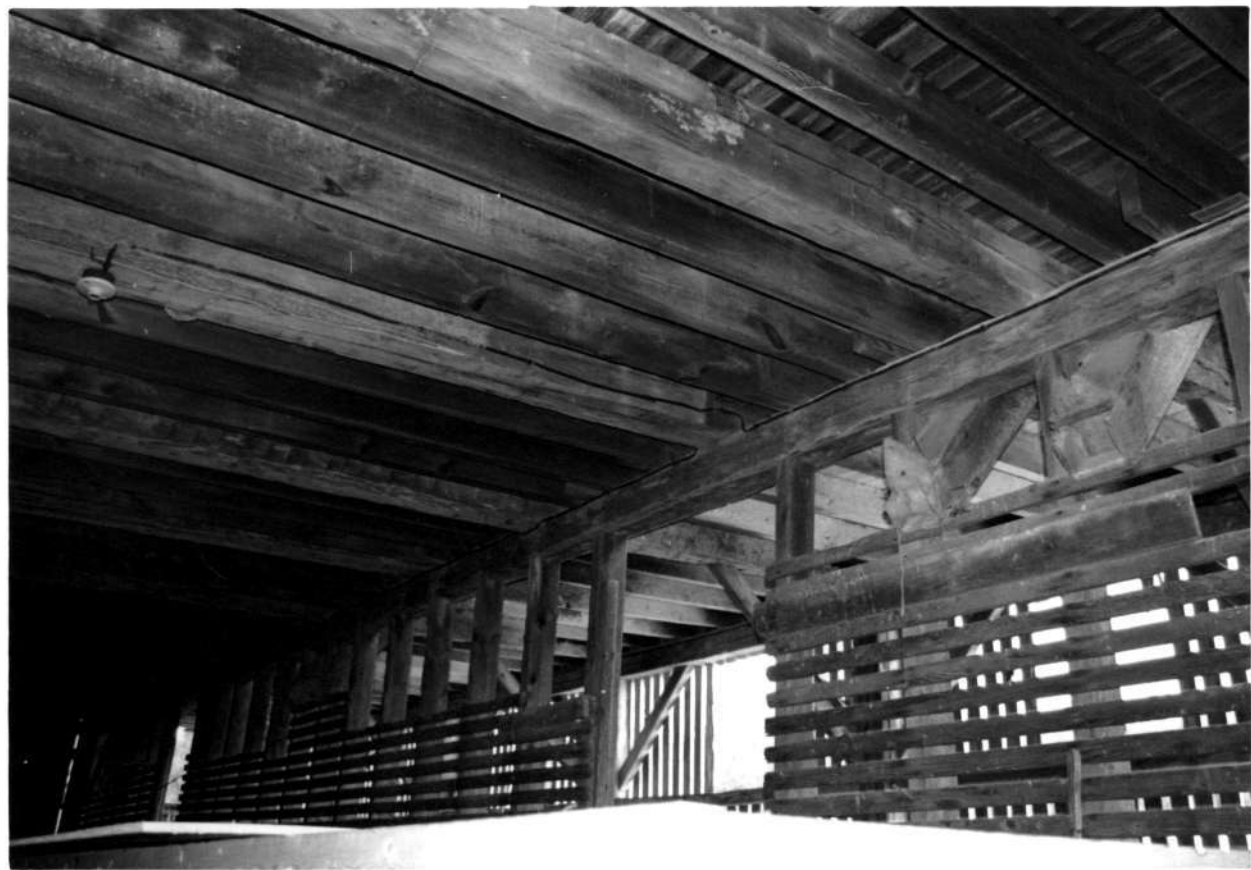
24/  
38

grain chutes along the interior side of the north corn crib. The second story, which covers both corn cribs and the wagon shed, appears to have been used for grain storage. The building sits on a stone foundation. There is a banked earthen access ramp to the doors on both the east and west end with concrete retaining walls. The corrugated metal roof covers earlier wood shingles. There is a large shed addition on the southeast side of the building.

Wagonshed/Corncrib interior, detail showing grain shutes  
from upper storage

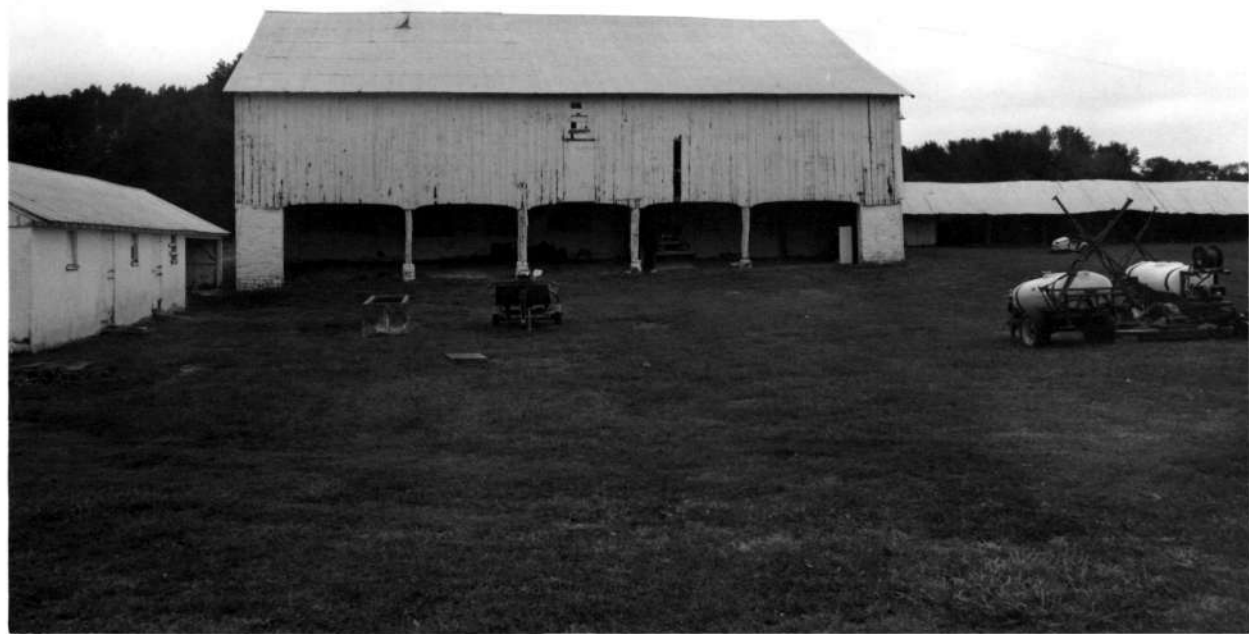
25/  
38

**Bank Barn:** The large hewn timber frame barn with its wide, posted forebay is described in Robert Ensminger's Pennsylvania Barn morphology as an "Extended Supported-Forebay Barn" (1800-1920) commonly found in southeastern Pennsylvania counties and in particular in Chester County just north of Cecil County: "In early examples of extended barns, forebay depths of up to 15 feet, combined with a long, unbroken front roof slope...The forebay beams of extended supported-forebay barns rest on top of the front stable wall at one end and on a heavy forebay cross beam at the other end. The position of a cross beam below the forebay beams is a key diagnostic difference between these and Sweitzer barns. The forebay cross beam is necessarily supported by a row of posts or columns." (Ensminger, p. 87) One example barn given by Ensminger, dated 1810 and located in Lehigh County, PA, exhibits the enclosed forebay ends created by the extension of the stone foundation walls, which support the forebay cross beam along with the posts. (Ensminger, p. 127) The Grove Farm Bank Barn has the long, unbroken front roof slope and wide extended forebay supported by a cross beam, enclosed stone ends, and heavy wooden posts on stone piers. The forebay faces south, shading the stabling area within the lower level of the barn. Stables for horses are located in both the east and west ends with the larger middle section taken up with cattle stabling. The barn has a raised stone foundation, built into the low rise of the hill. Access to the upper, framed level of the barn is through the north elevation using a concrete ramp on an earthen abutment with stone and concrete retaining walls. The abutment does not reach the barn wall, leaving an open area under the ramp. The barn interior is divided into thirds with the middle threshing floor and hay mows on either side. The framing bents are formed with queen posts. The south, west, and north walls of the barn are covered with vertical board and batten siding, in very poor condition on the north side. The east wall is covered with metal siding. The roof is covered with metal sheets.

**Attached Equipment Shed:** A hewn timber frame pole shed is attached to the barn on the east wall. It is constructed identically to the other equipment shed (attached to the Quarter and Wagon Shed) except that there is an enclosed section on the west end adjoining the barn that may have housed small animals.

**Concrete Block Building:** This one-story building constructed of concrete block sits perpendicular to the Bank Barn just south of the southwest corner of the barn. It is a gable-end building with the north end extended with a frame open storage area (open on the east side). The block building has two stable-type split doors and three windows on the east elevation and one split door on the south elevation and may have served as additional stabling (no interior access). The whole building is covered with a metal roof. Immediately to the east of this building in the barn yard area, is a large concrete trough.

Bank Barn, south elevation, view N showing attached  
equipment shed (right/east) and Concrete Block Bldg  
(left/west)

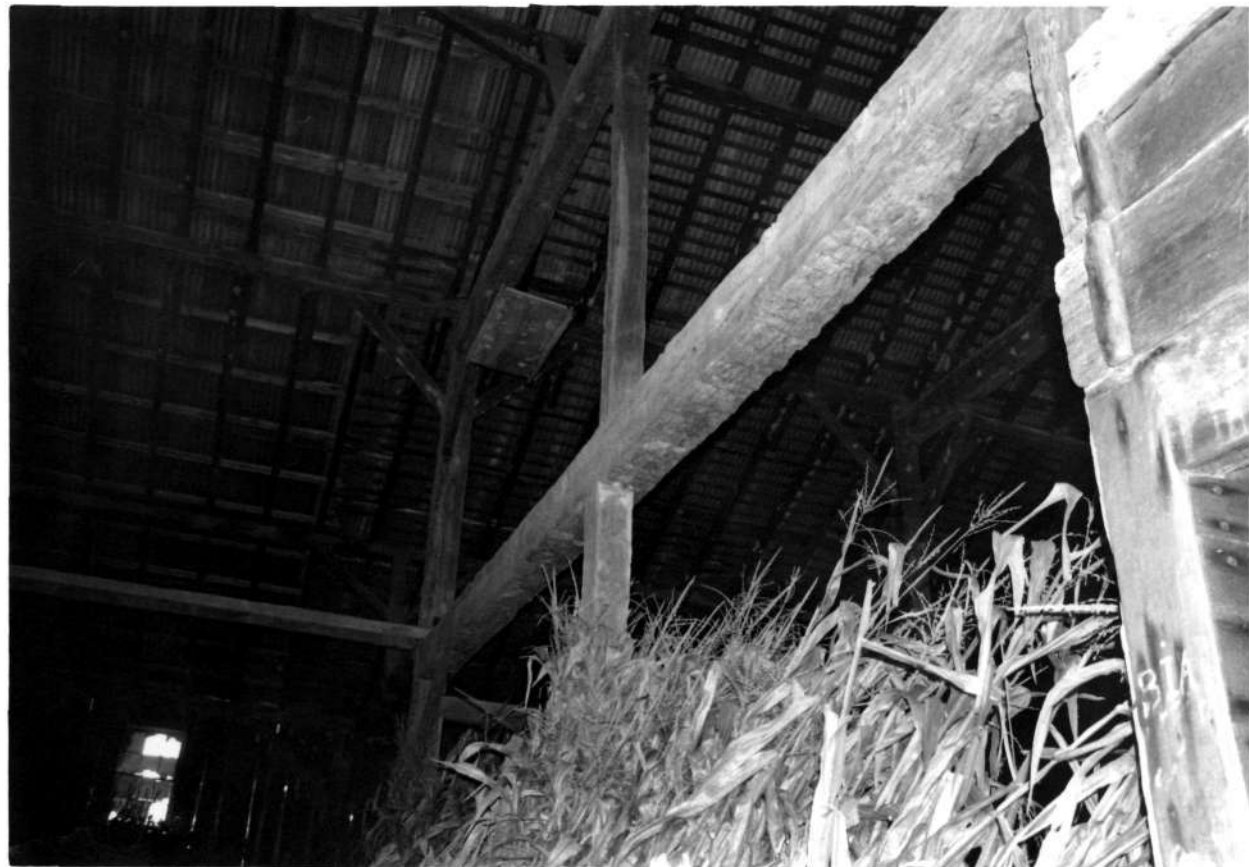
29/  
38

Bank Barn, interior, upper story detail of framing

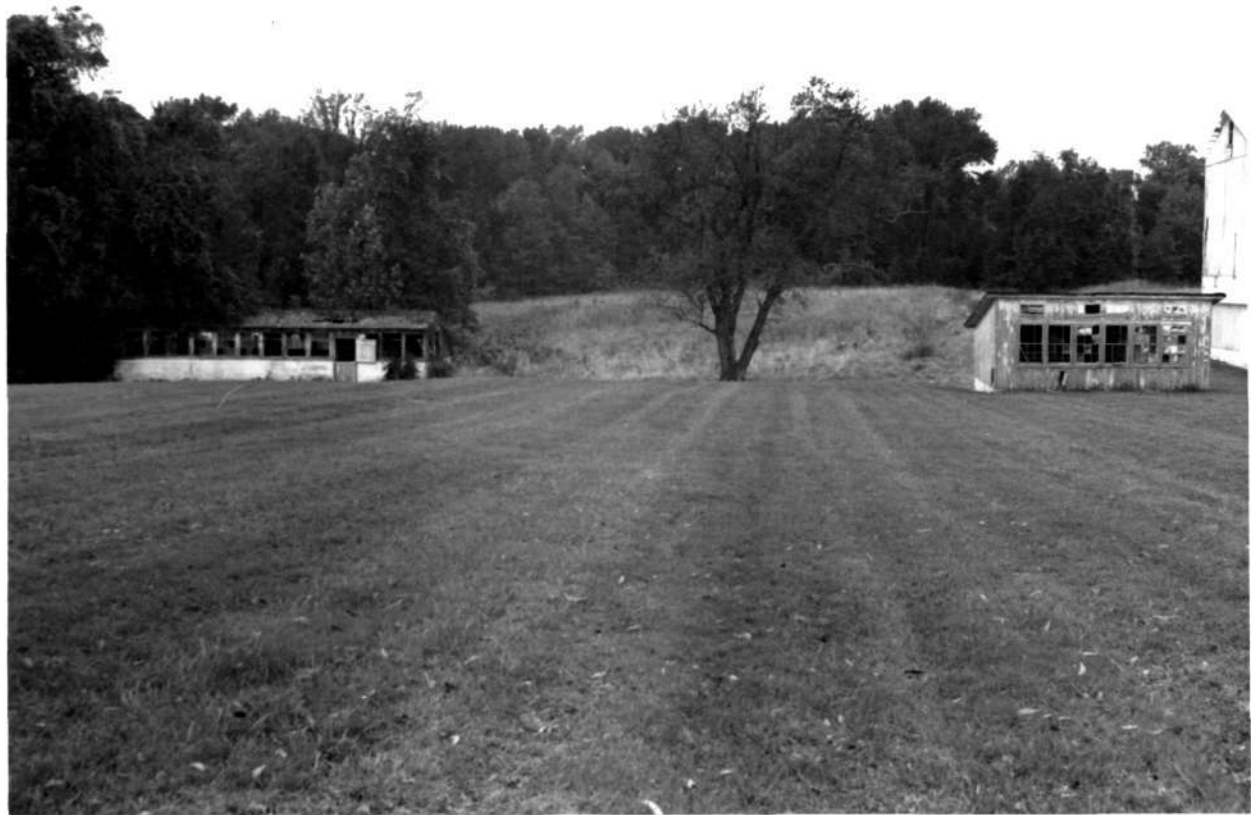
31/  
38

**Chicken House:** Just southwest of the Block Building is a frame chicken house on concrete block foundation. The shed-roofed building faces south with a bank of 6 over 6 sash windows. The walls are covered with vertical boards; the roof is covered with metal sheets.

**Hog Barn:** Northwest of the Chicken House is a Hog Barn of similar construction - frame on concrete block foundation facing south with a bank of fixed 9-light windows. The walls are vertical boards and the roof is wood shingle. Inside are horizontal slatted pens.

Hog Barn (left/west bldg) and Chicken House (right/east bldg)

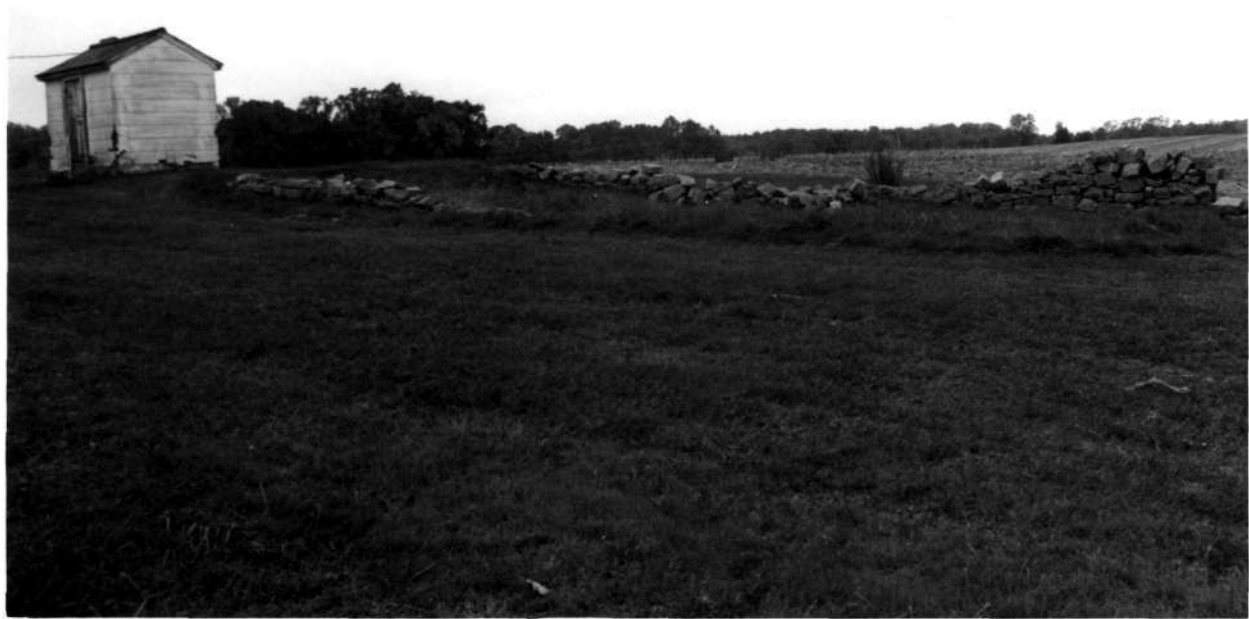
33/  
38

**Stone Foundation:** A stone foundation is located south of the Chicken House and Hog Barn. It consists of large granite blocks with some mortar still intact. The foundation is oriented with the ends north and south, approximately 35 feet in length and 15 feet wide.

Stone foundation and Pump House, view SW
